Milwaukee County Courthouse – Façade Evaluation

PROJECT: Milwaukee County Courthouse
Façade Evaluation
Milwaukee, Wisconsin

DATE: June 8, 2010
FILE NO: 301164

FACADE EVALUATION

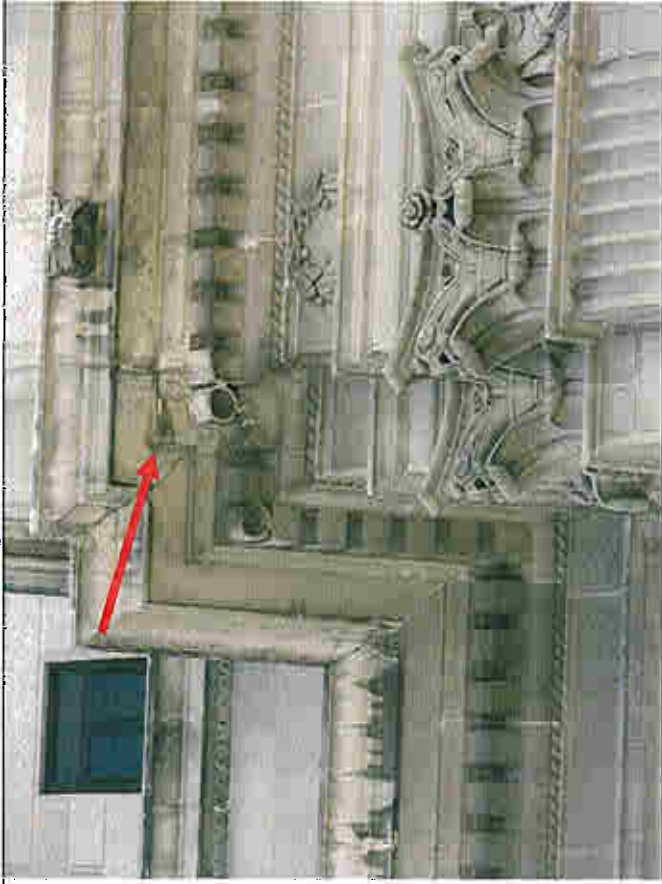
On the morning of March 4, 2010, a spall of limestone, approximately 10" in diameter, was found on the ground, adjacent to the west side of the building (Photos #1 - #3). The area was cordoned off as a safety precaution.

Photo #1 – Location of limestone spall

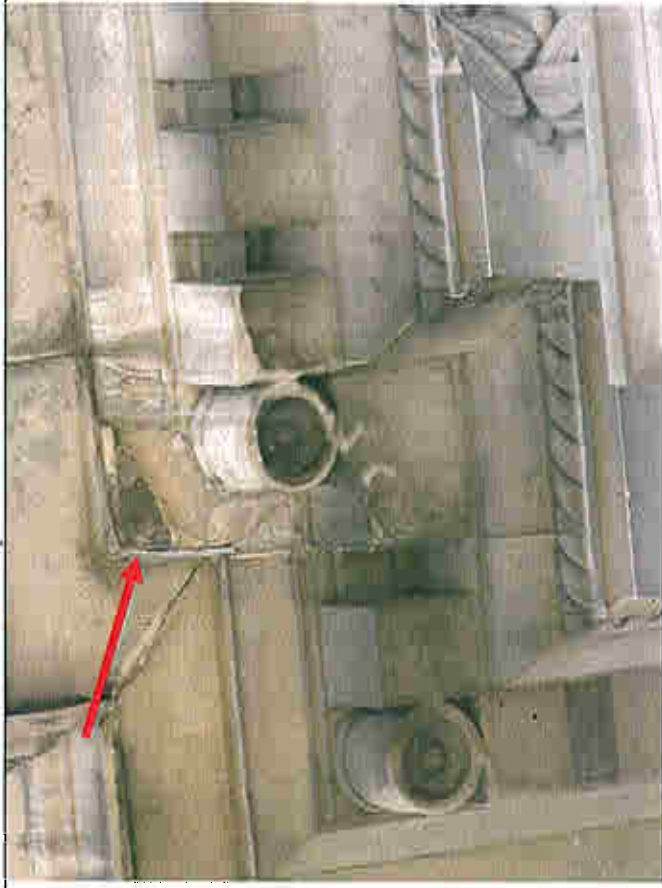
Photo #2 – Location of limestone spall

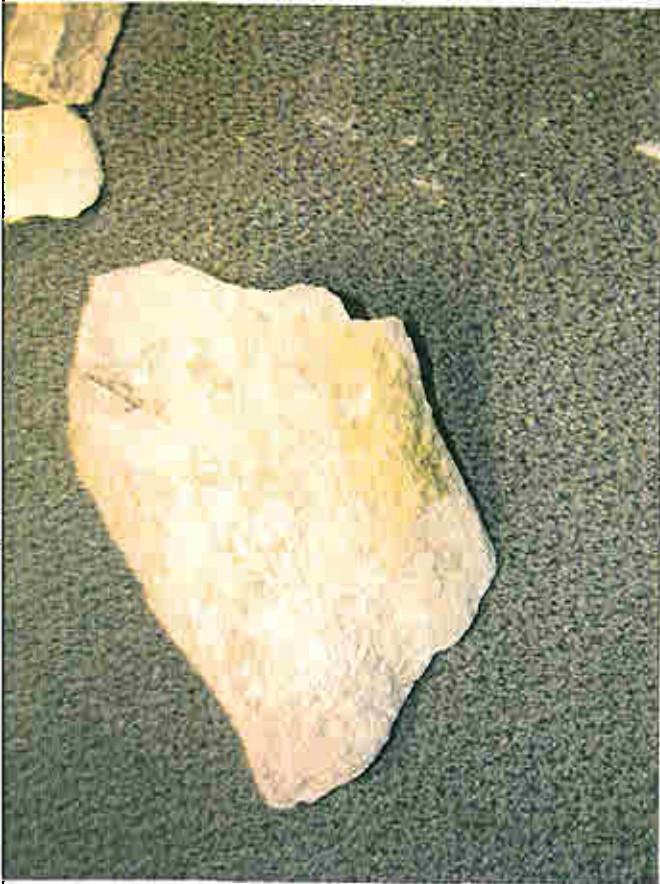
Photo #3 – Remains of limestone spall

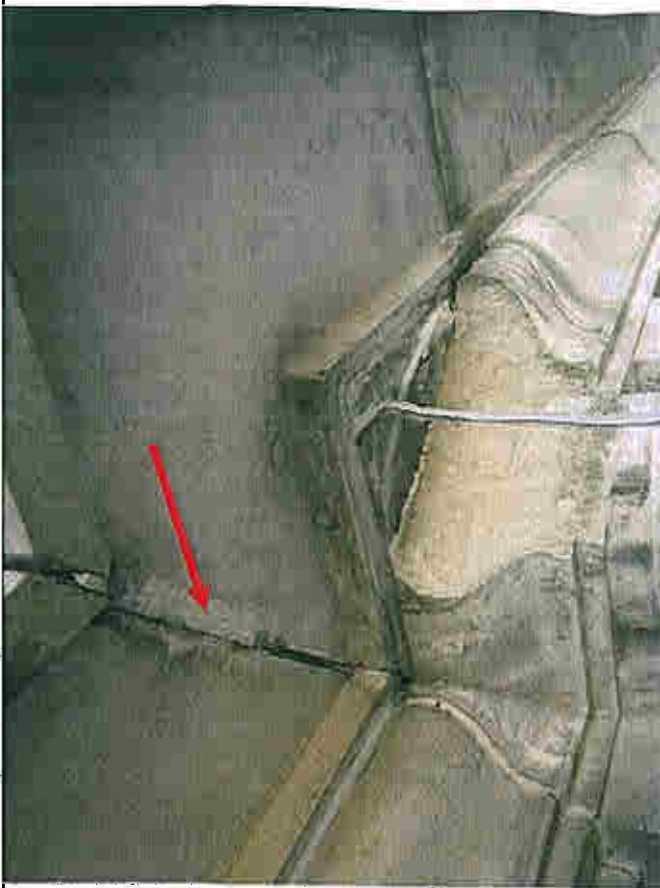
Photo #4 – Open mortar joints in limestone cornice

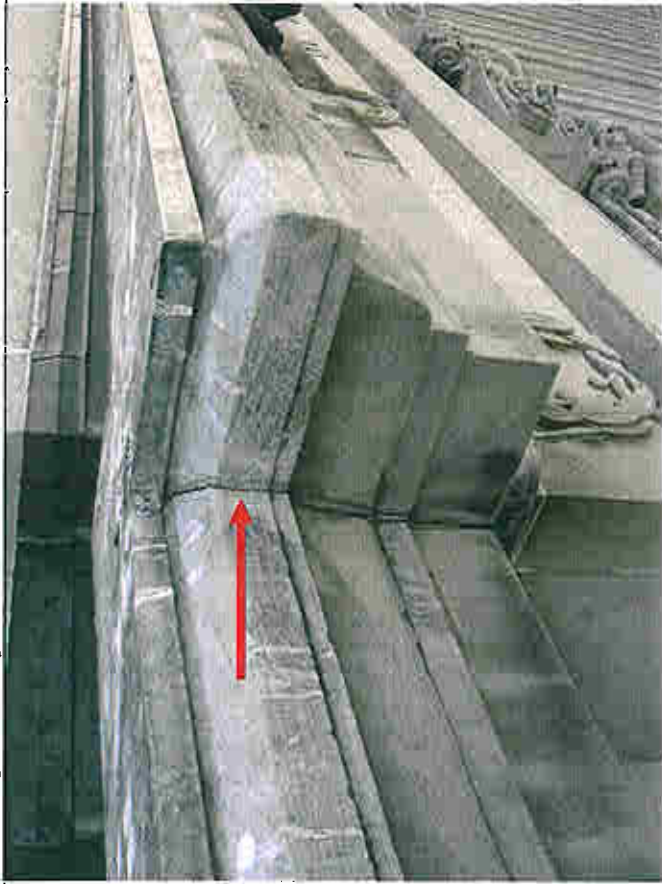
Photo #5 – Open mortar joints in limestone cornice

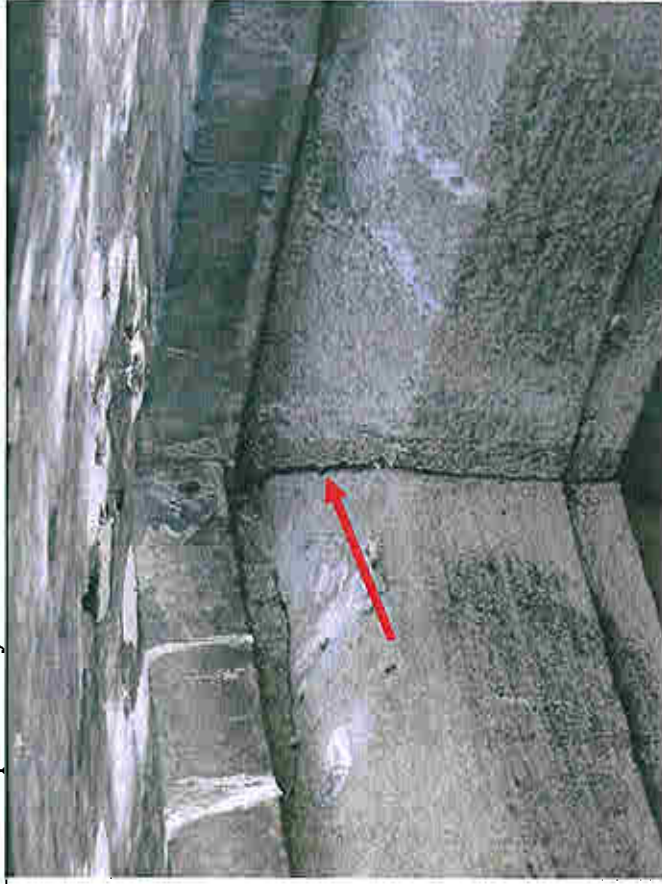
Photo #6 – Open mortar joints in limestone cornice

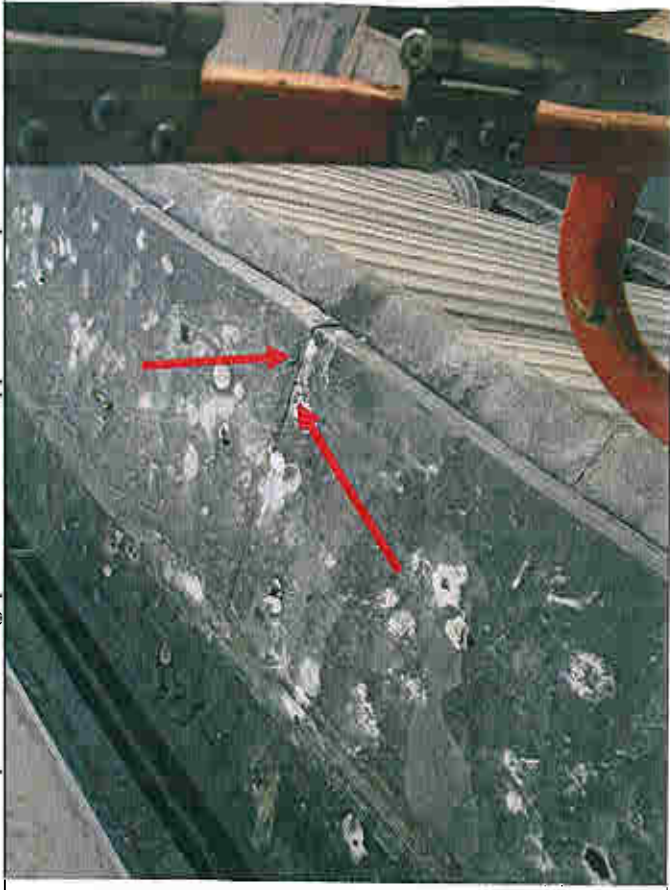
Photo #8 – Open seam and gap at fasteners of copper cornice cap

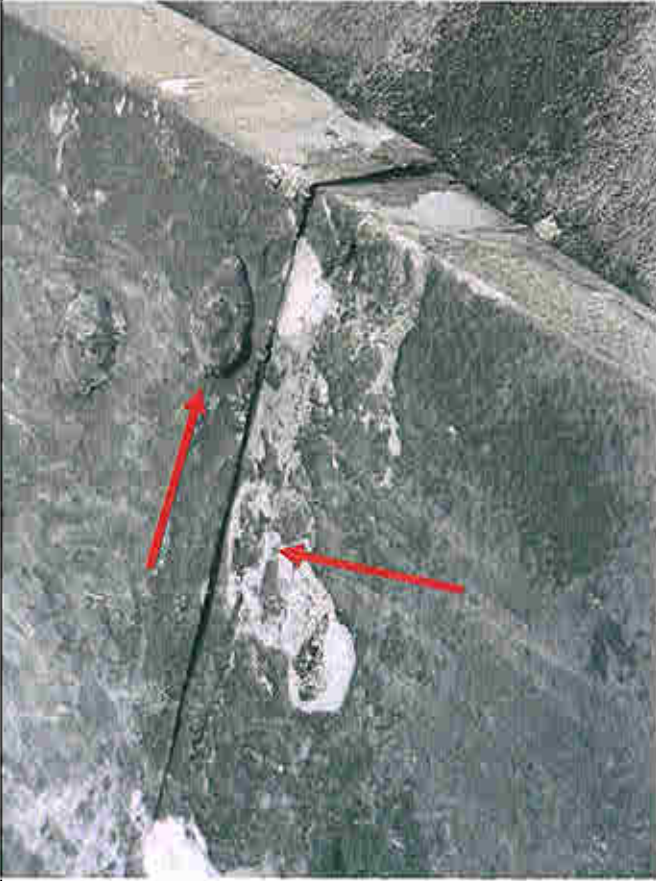
Photo #9 – Open seam and gap at fasteners of copper cornice cap

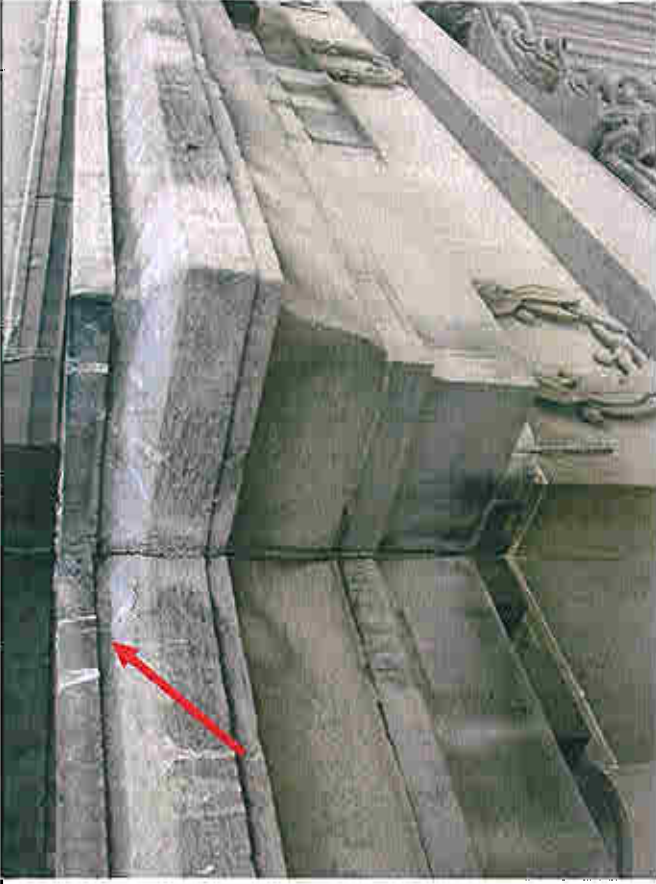
Photo #10 – Limestone spall beneath copper cornice cap

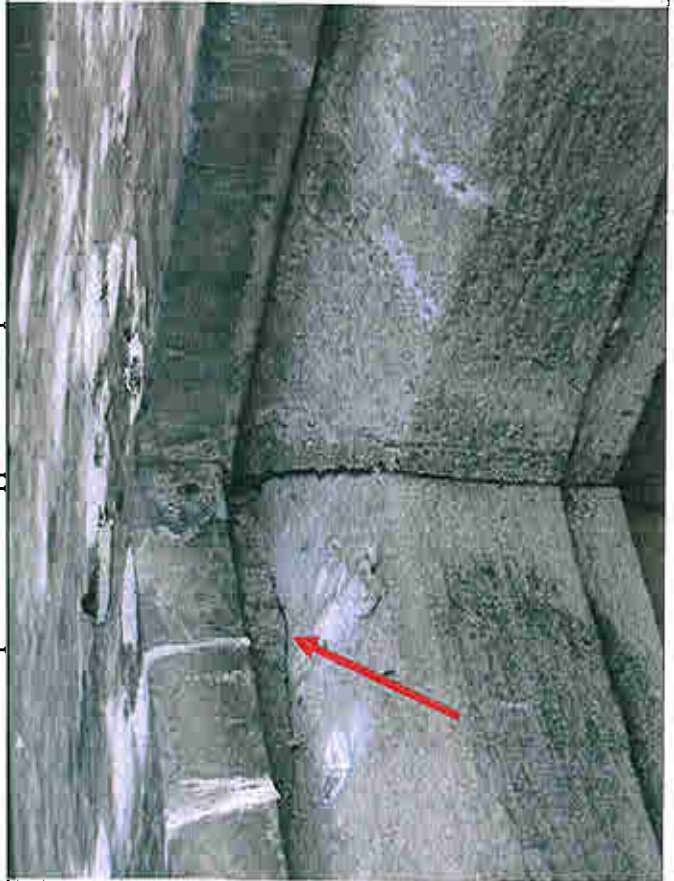
Photo #11 – Limestone spall beneath copper cornice cap

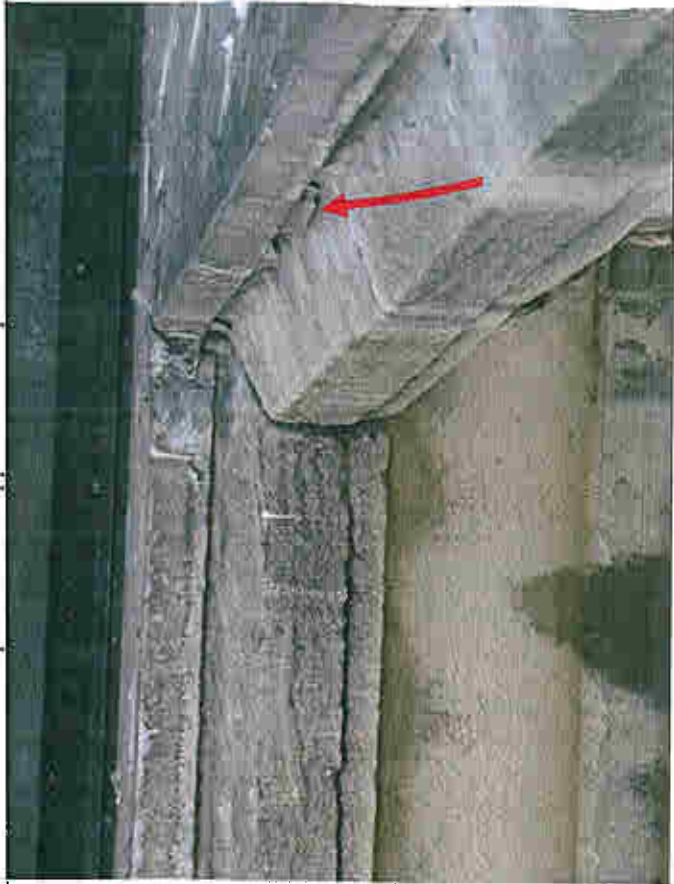
Photo #12 – Limestone spall beneath copper cornice cap

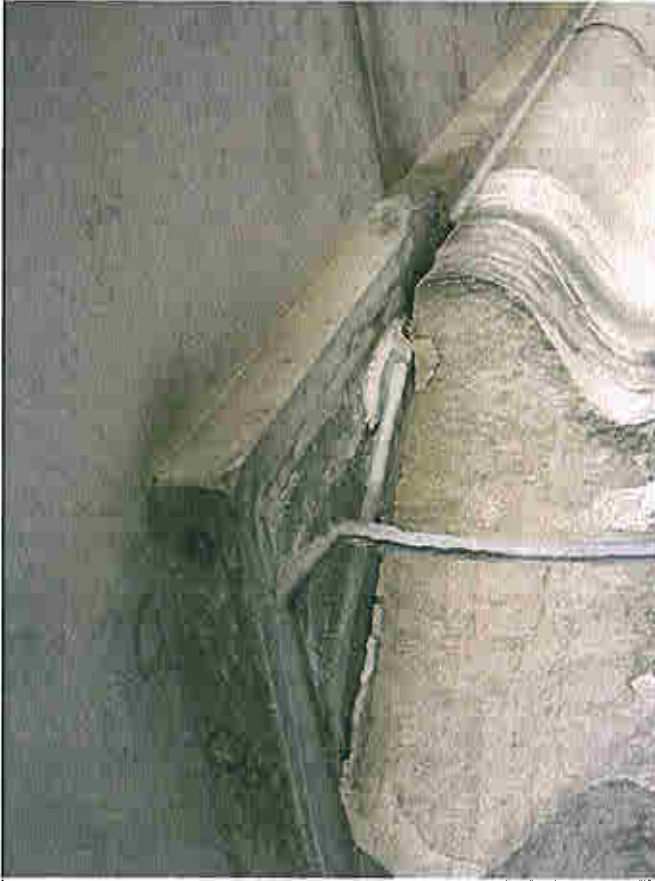
Photo #13 – Joint sealant and wet backer rod above spall

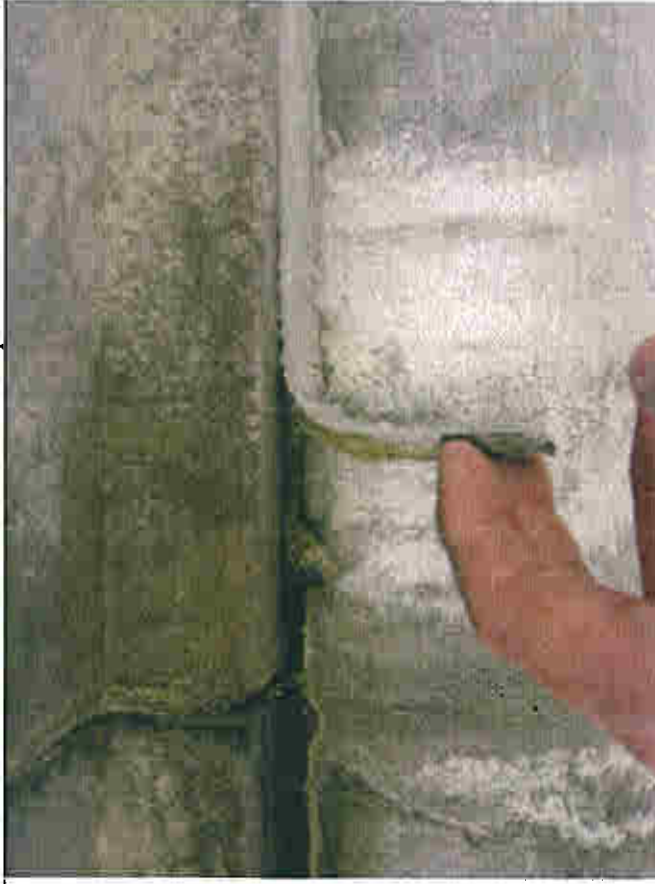
Photo #14 – Joint sealant and wet backer rod above spall

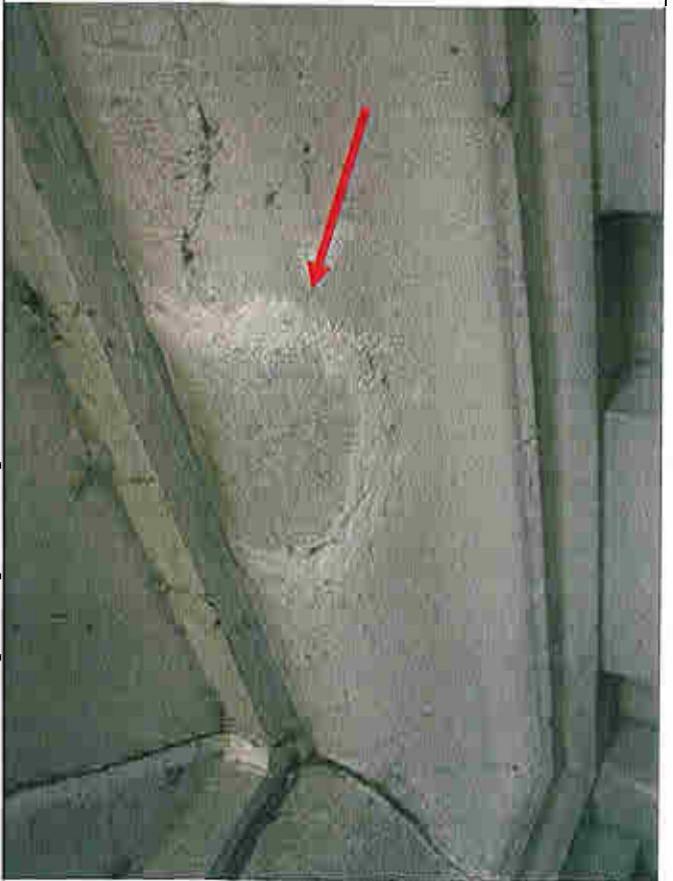
Photo #15 – Previous repairs adjacent to spall

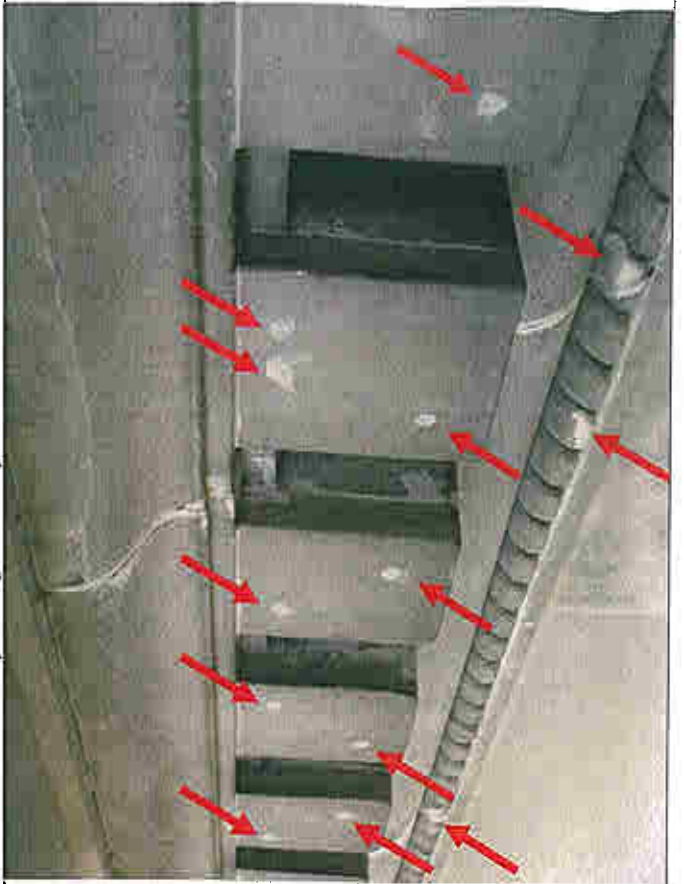
Photo #16 – Previous repairs adjacent to spall

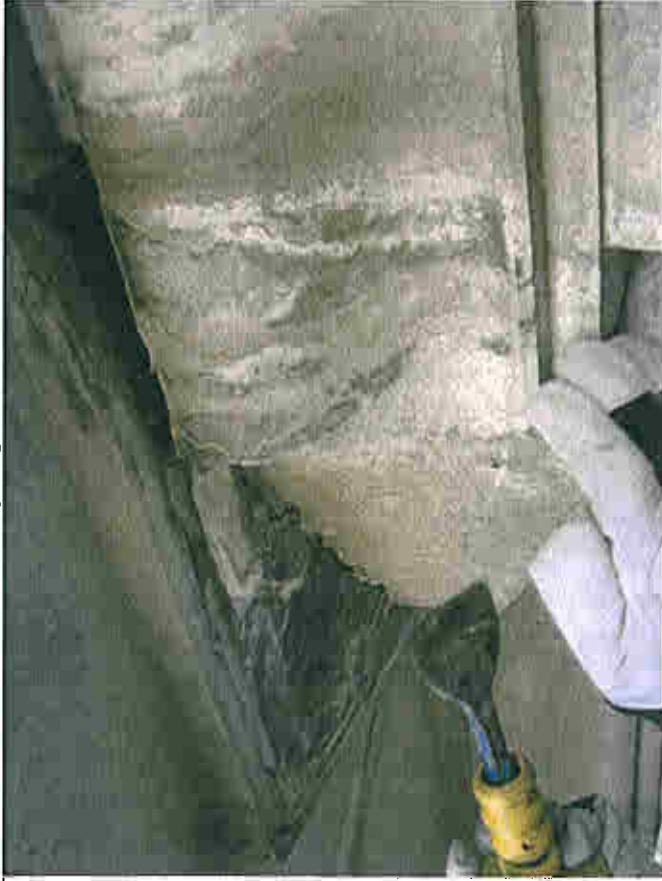
Photo #17 – Removal of loose masonry at spall

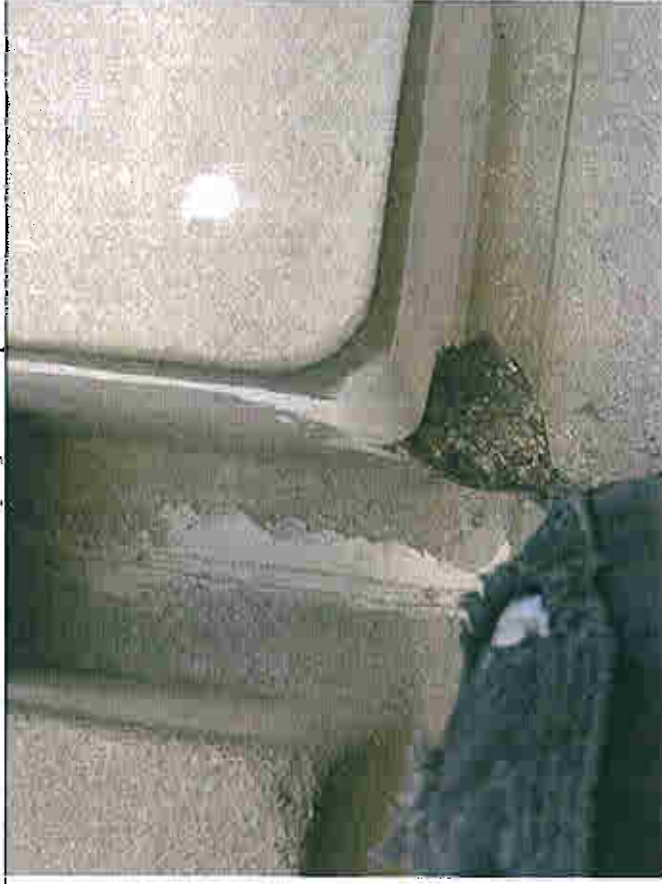
Photo #18 – Removal of loose masonry adjacent to spall

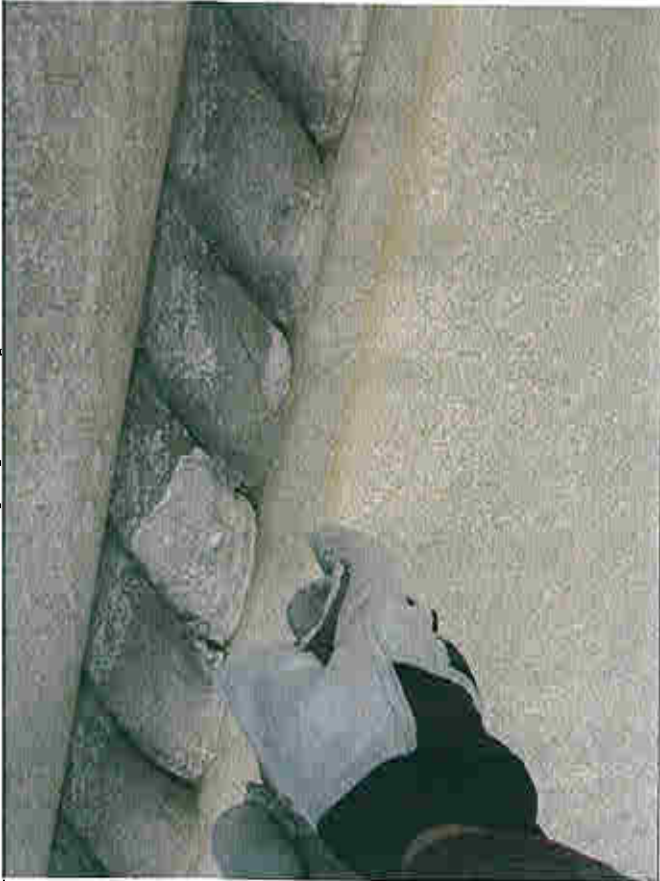
Photo #19 – Removal of loose masonry adjacent to spall

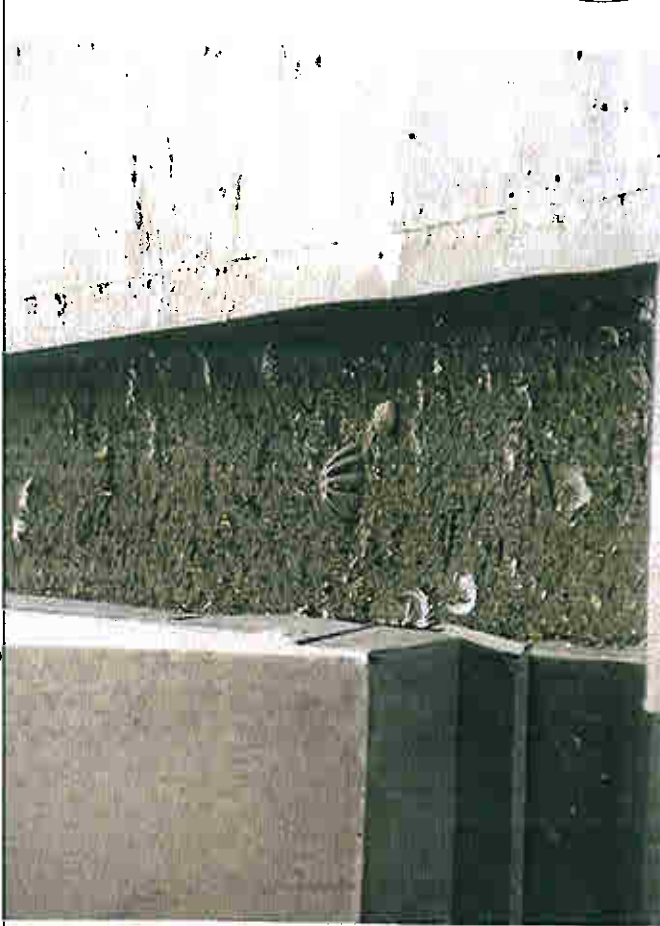
On March 9, 2010, and March 10, 2010, hands-on examination of the entire west elevation was performed via a 135' man lift. Examination from the roof level was also conducted on March 10, 2010. Debris was observed in the copper gutter, above the cornice, which clogged the roof drains (Photos #20 - #23). Cracks, spalls, open mortar joints, and previous repairs were observed (Photos #24 - #29). Areas of loose limestone were removed.

Photo #20 – Debris in west gutter

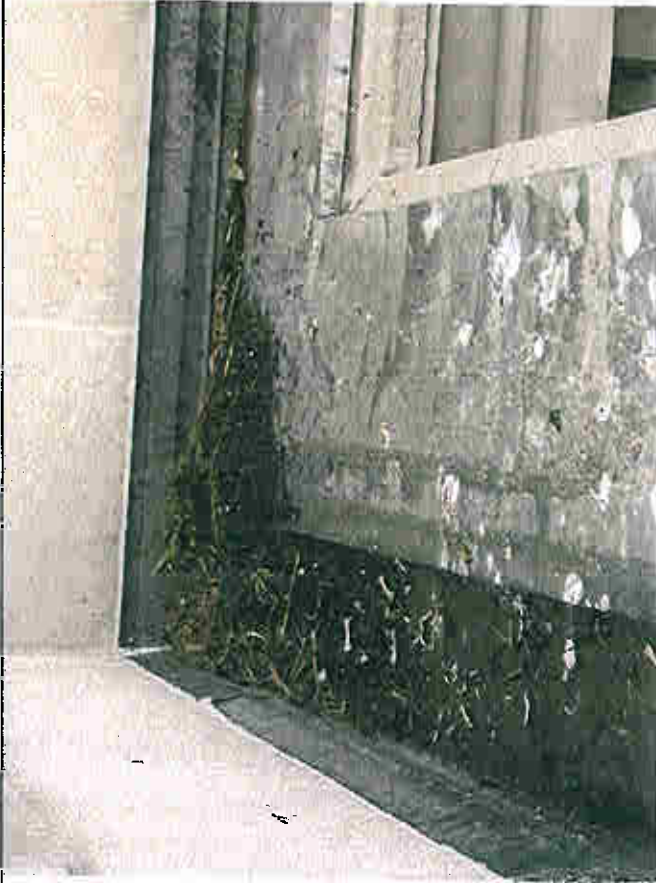
Photo #23 – Bird's nest in west gutter

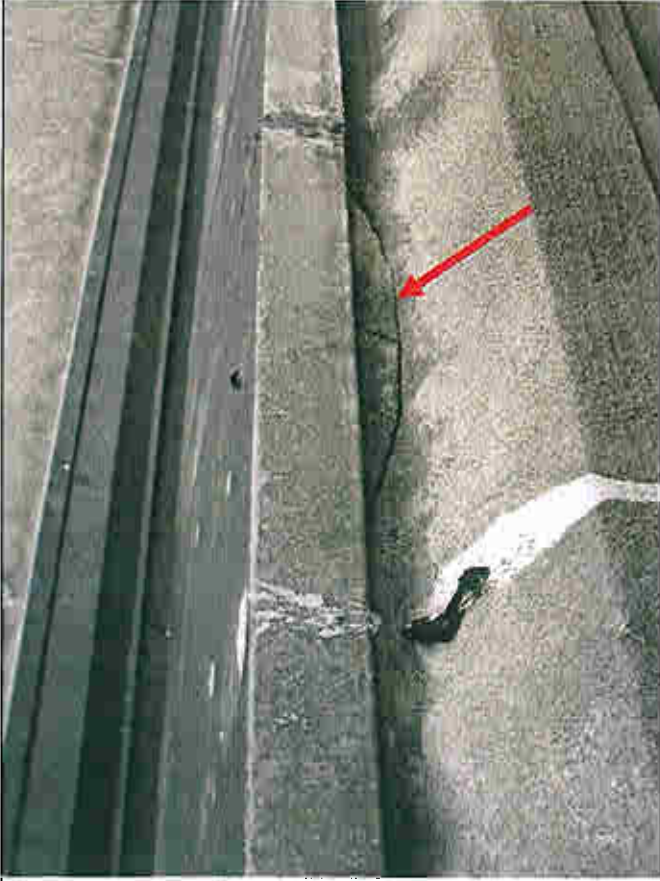
Photo #25 -- Spall beneath cornice cap

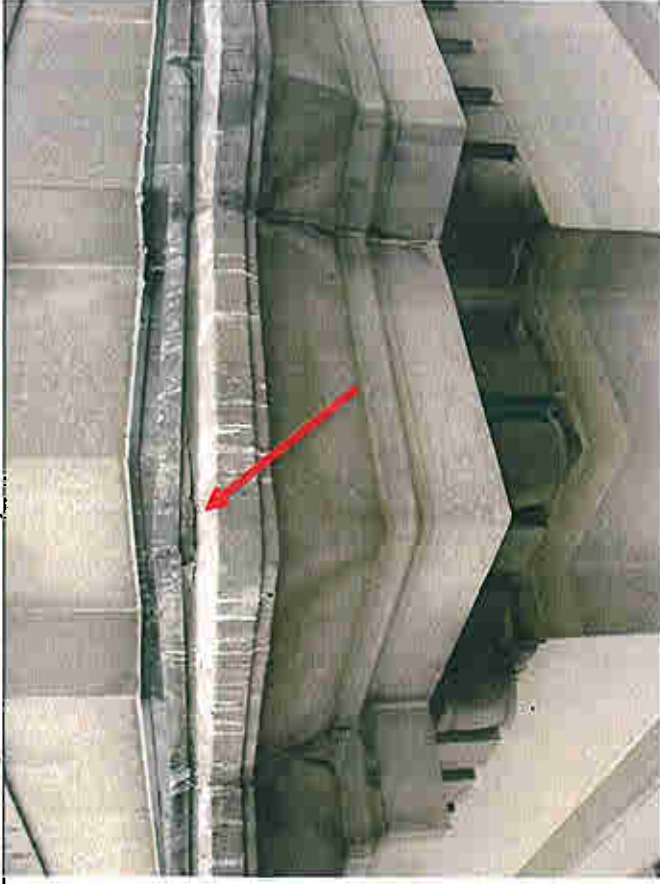
Photo #26 -- Spall beneath cornice cap

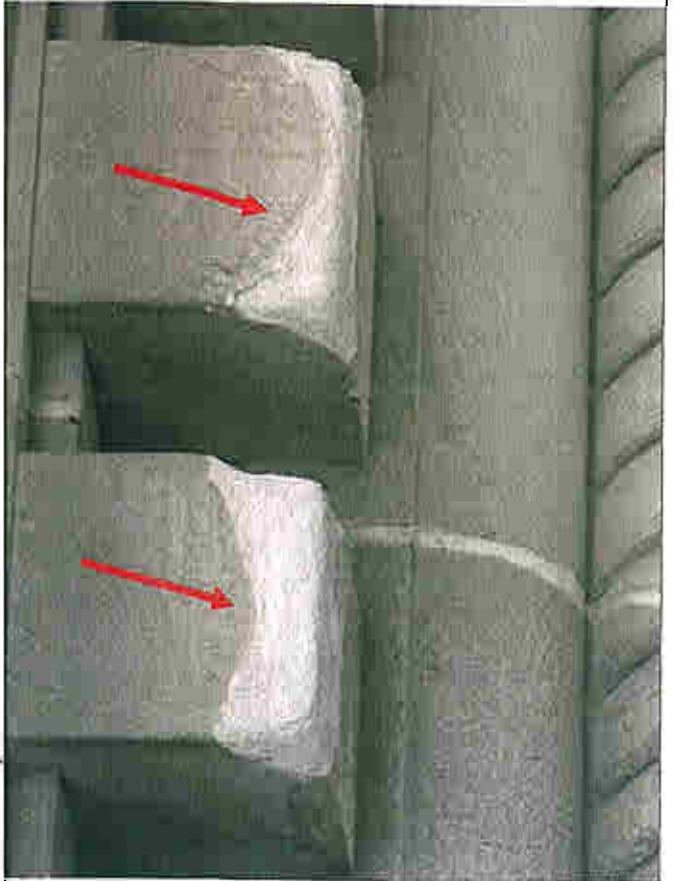
Photo #27 -- Spalls in limestone dentils

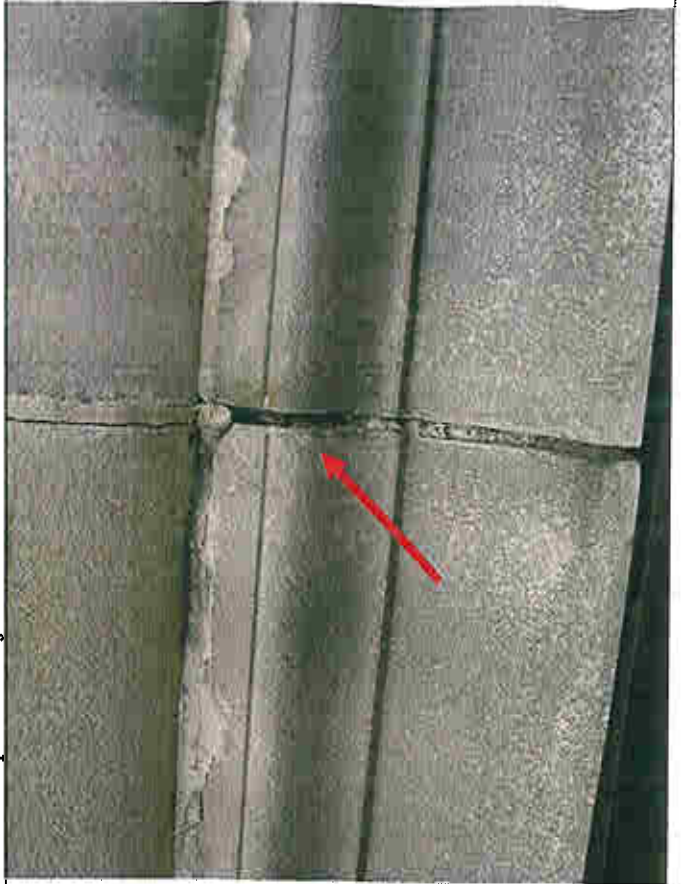
Photo #28 -- Open mortar joint in cornice

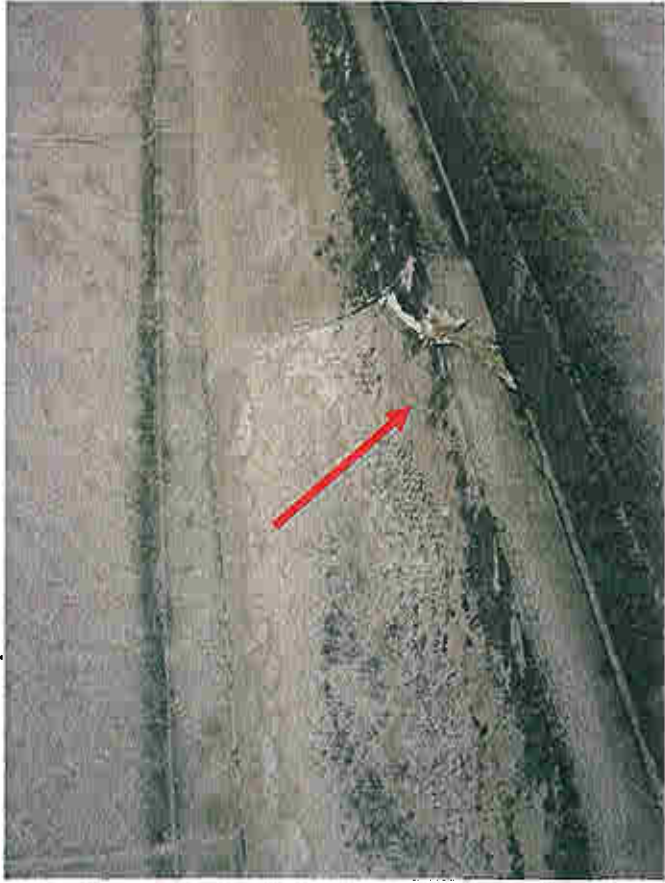
Photo #29 – Previous repair of crack

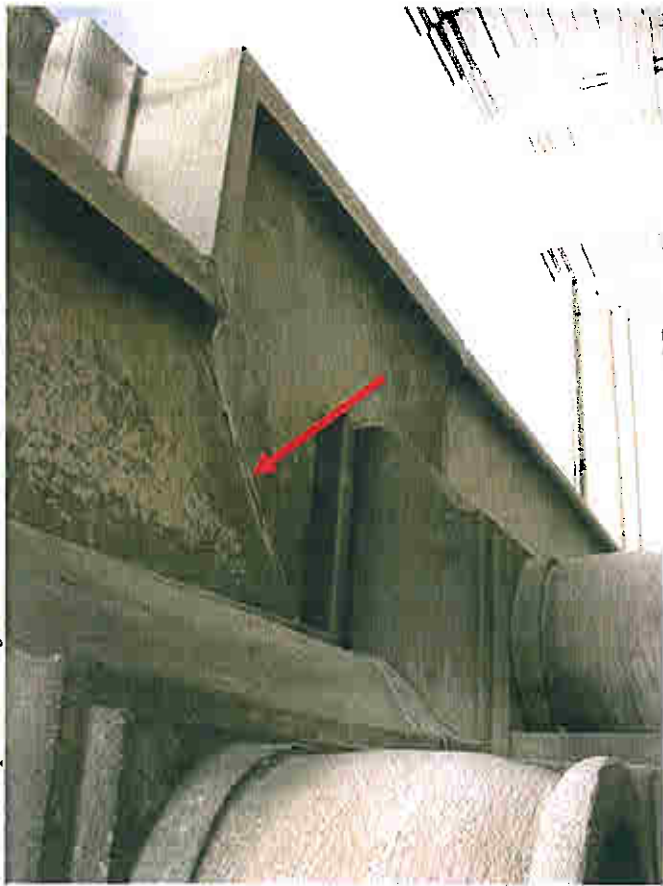
<u>Quantities</u>	
West Elevation	100% at cornice, 50% elsewhere
South Elevation	100% at cornice, 10% elsewhere
East Elevation	100% at cornice, 10% elsewhere
North Elevation	100% at cornice, 10% elsewhere

Photo #33 – Open mortar joint

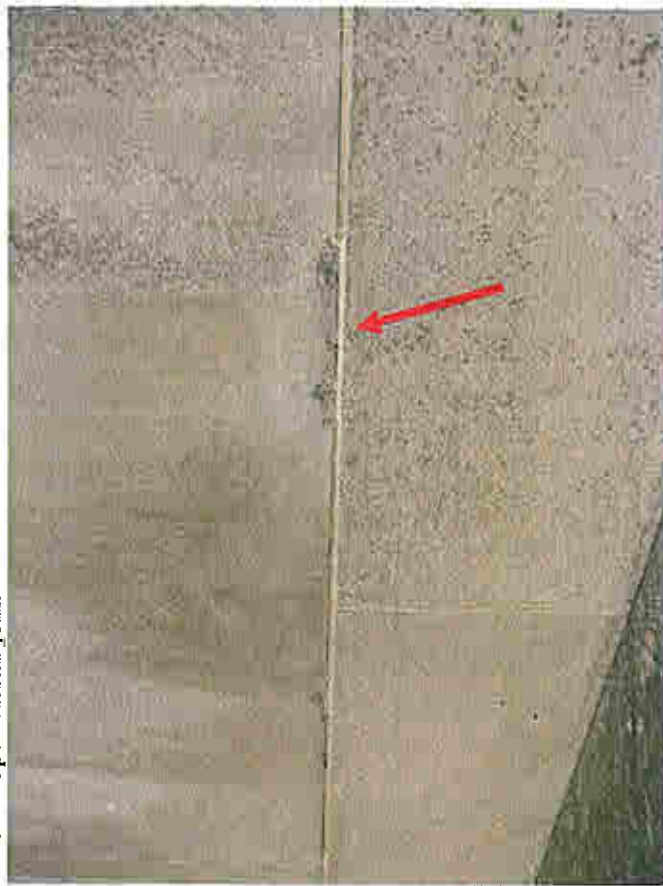
Photo #34 – Open mortar joint

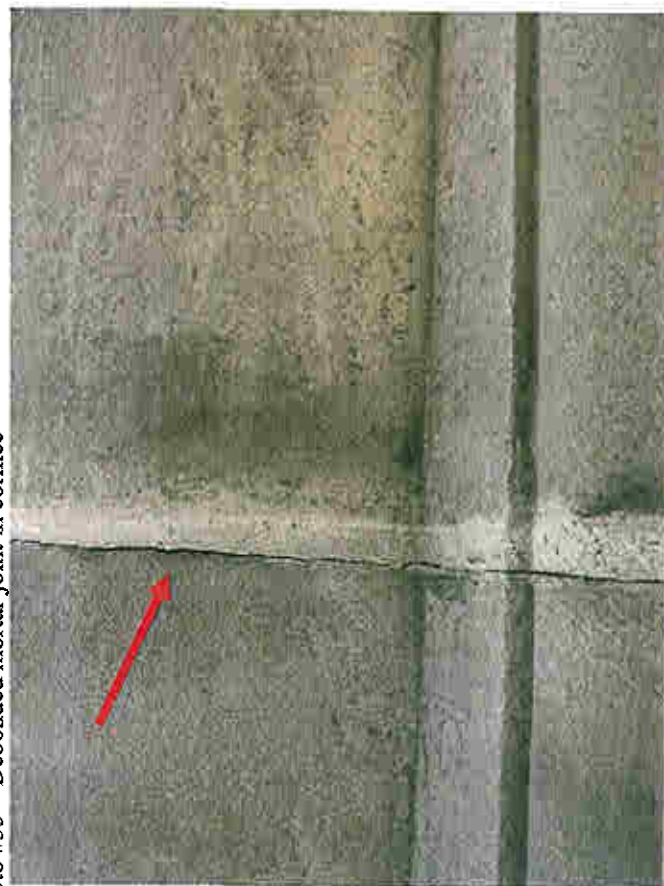
Photo #35 – Debonded mortar joint in cornice

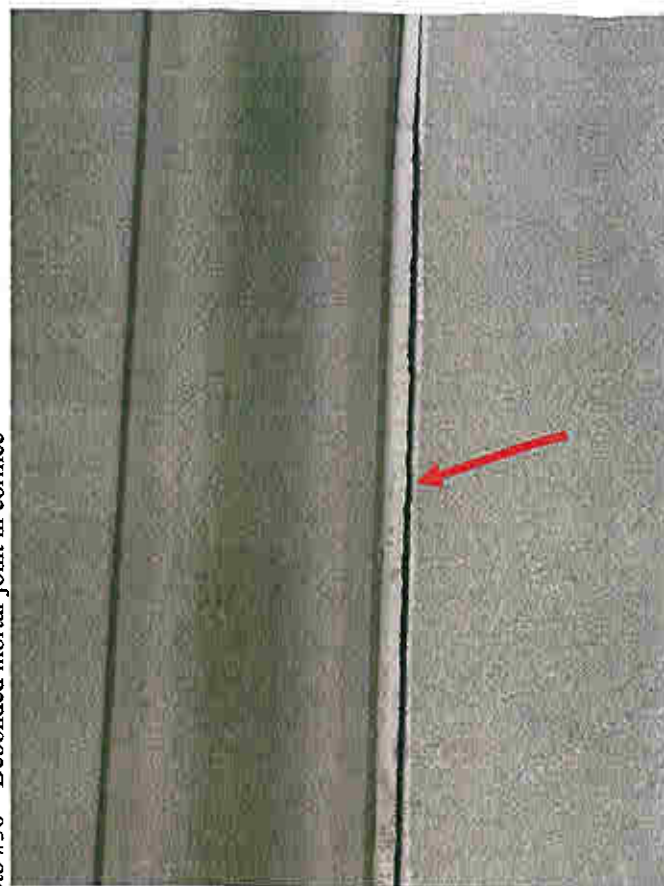
Photo #36 – Debonded mortar joint in cornice

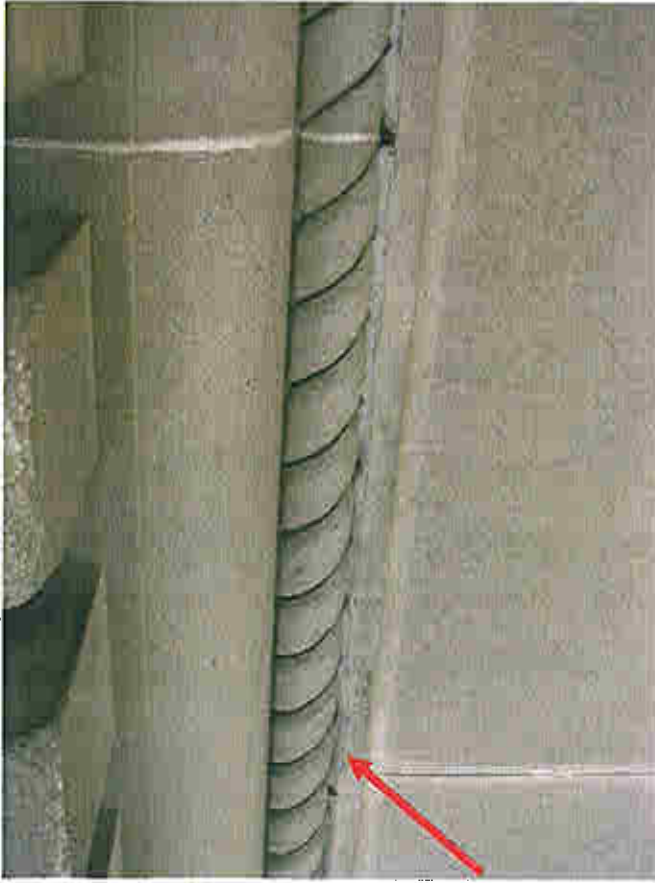
<u>Quantities</u>	
West Elevation	100% at cornice, random locations above gutter line
South Elevation	100% at cornice, random locations above gutter line
East Elevation	100% at cornice, random locations above gutter line
North Elevation	100% at cornice, random locations above gutter line

Photo #37 – Application of joint sealant at cornice

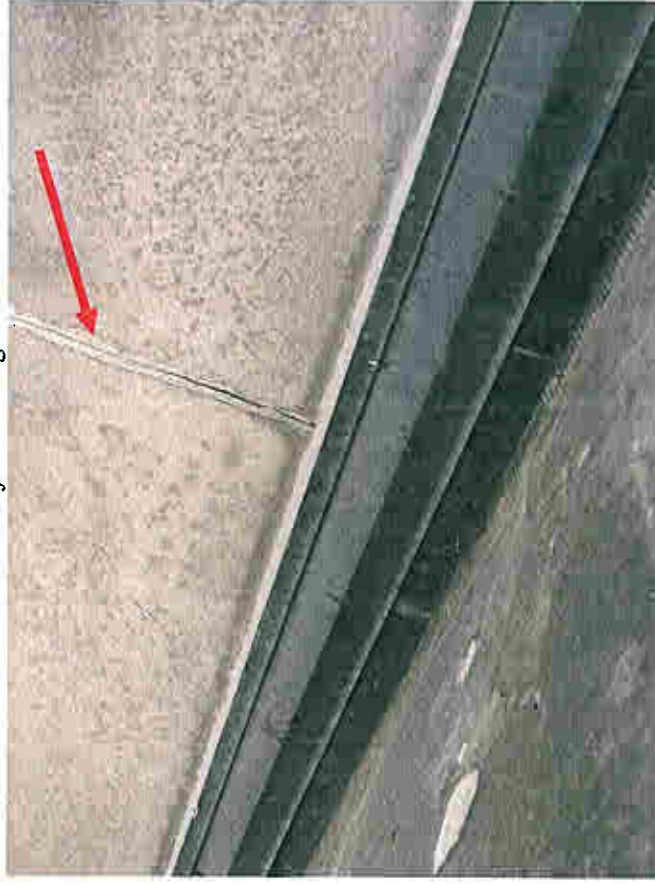
Photo #38 – Failed sealant at limestone joint above gutter

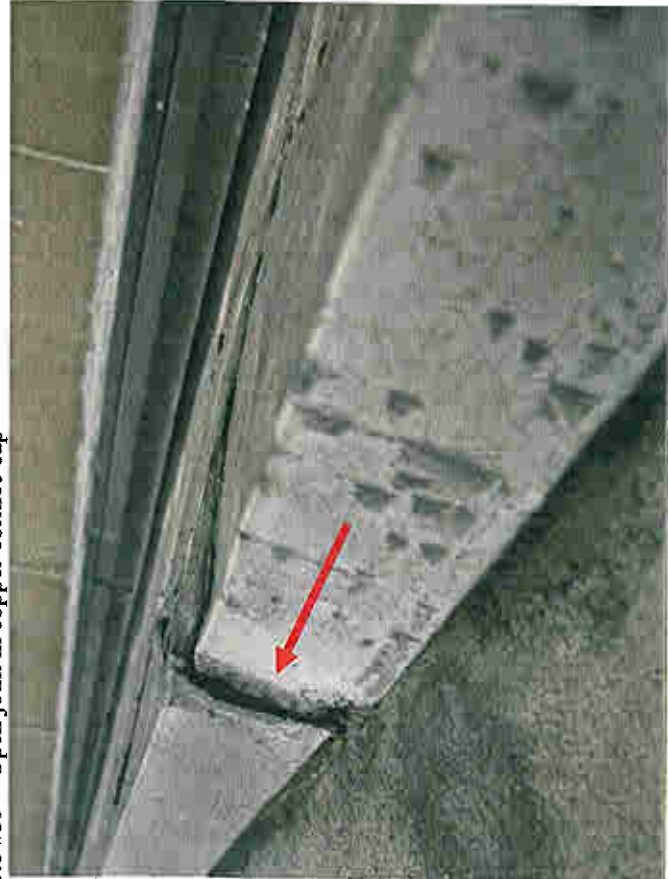
Further investigation of the copper gutter and cornice cap was also performed by Langer Roofing and Sheet Metal, Inc., via the crane and basket. In a 100' section of the copper gutter, they noted 5 of 11 riveted and soldered seams were cracked. No expansion joints were installed in the gutter. A 20' section of counterflashing was removed. The gutters were mechanically fastened through the top of the gutter into the limestone behind. Only 2 of 9 fasteners remained intact. The copper counterflashing for the gutter was attached to the copper receiver with stainless steel screws. The receiver was set in the limestone and the joint was caulked. At numerous locations, the caulk had pulled away from the limestone. The gutters were installed over what appeared to be an asbestos base fabric. The copper cornice was fabricated from lead coated copper and was hooked and soldered to the front edge of the gutter. The outside edge of the cornice cap was fastened through the lead coated copper into the limestone cornice. At most locations, the fasteners were deteriorated. No expansion joints were incorporated into the cornice cap. In numerous locations, the soldered joints of the cornice are cracked. A corner section of the cornice cap was noticed to be detached upon our arrival at the site (Photo #74). Langer Roofing and Sheet Metal, Inc. re-attached this corner with stainless steel fasteners. Some of the copper counterflashings had been deformed, as a result of ice damming.

<u>Quantities</u>	
West Elevation	460 ln. ft. (entire length)
South Elevation	215 ln. ft. (entire length)
East Elevation	460 ln. ft. (entire length)
North Elevation	215 ln. ft. (entire length)
Total	1,350 ln. ft.

Photo #39 – Open joint in copper cornice cap

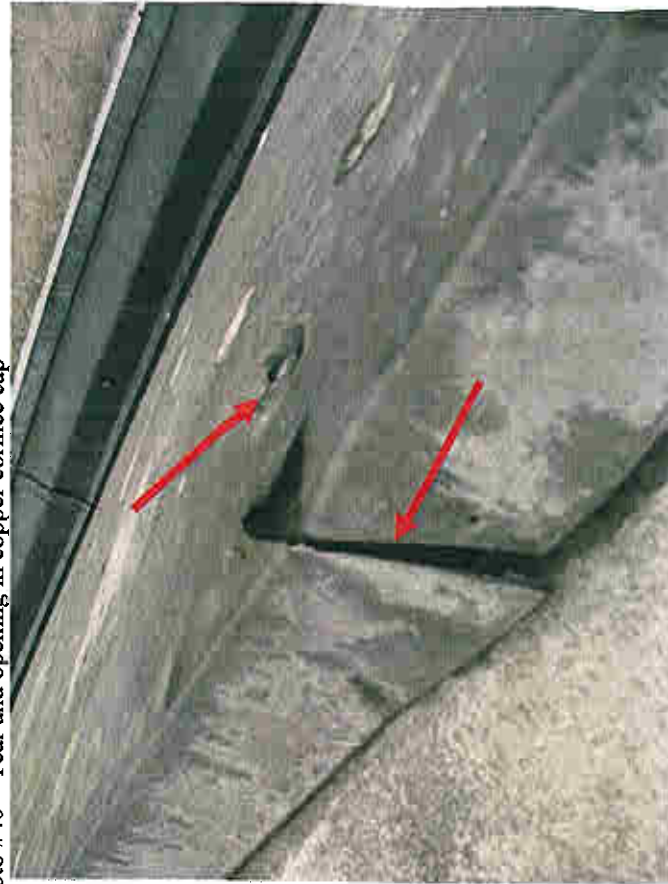
Photo #40 – Tear and opening in copper cornice cap

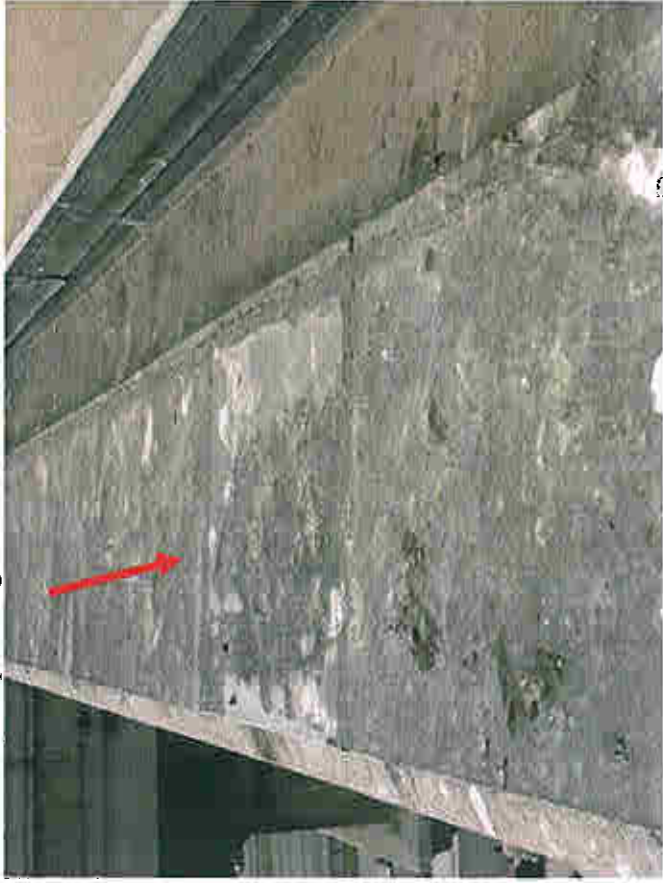
Photo #41 – Previous patch of gutter at southeast corner

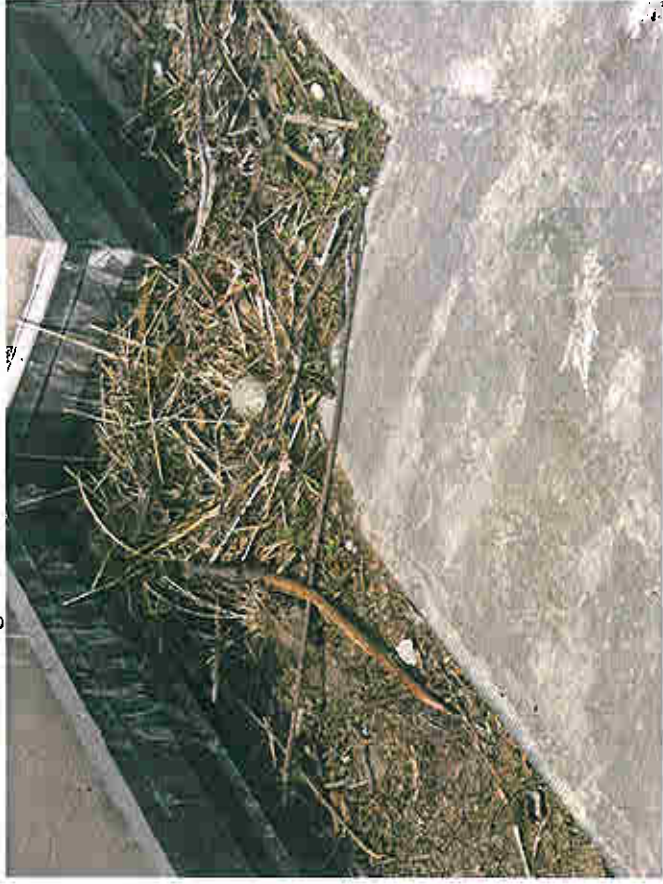
<u>Quantities</u>	
West Elevation	X
South Elevation	
East Elevation	X
North Elevation

Photo #42 – Bird's nest in gutter of southeast corner

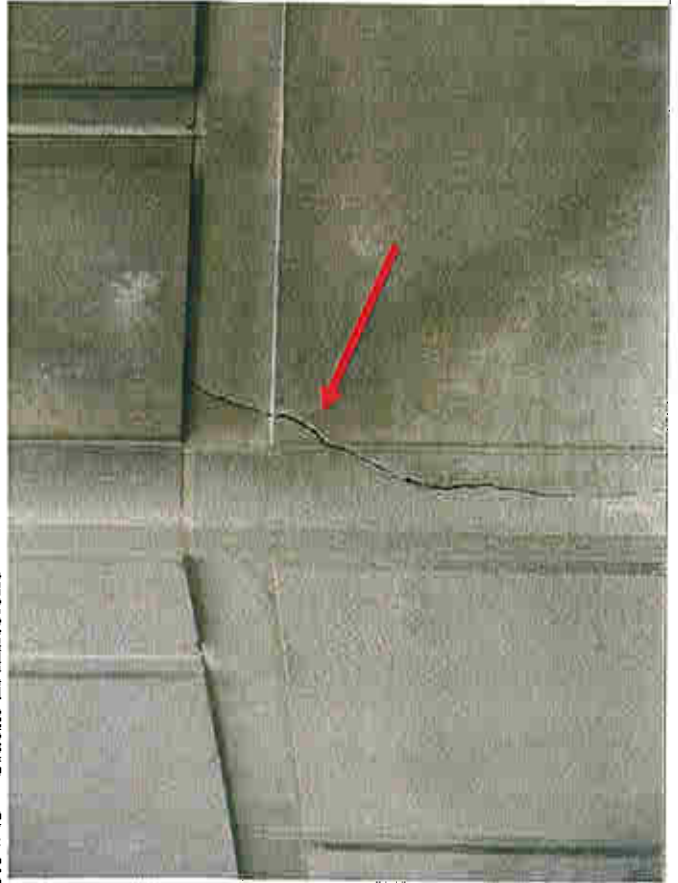
<u>Quantities</u>	
West Elevation	15 ln. ft.
South Elevation	15 ln. ft.
East Elevation	35 ln. ft.
North Elevation	30 ln. ft.
Total	95 ln. ft.

Photo #43 – Cracks in limestone

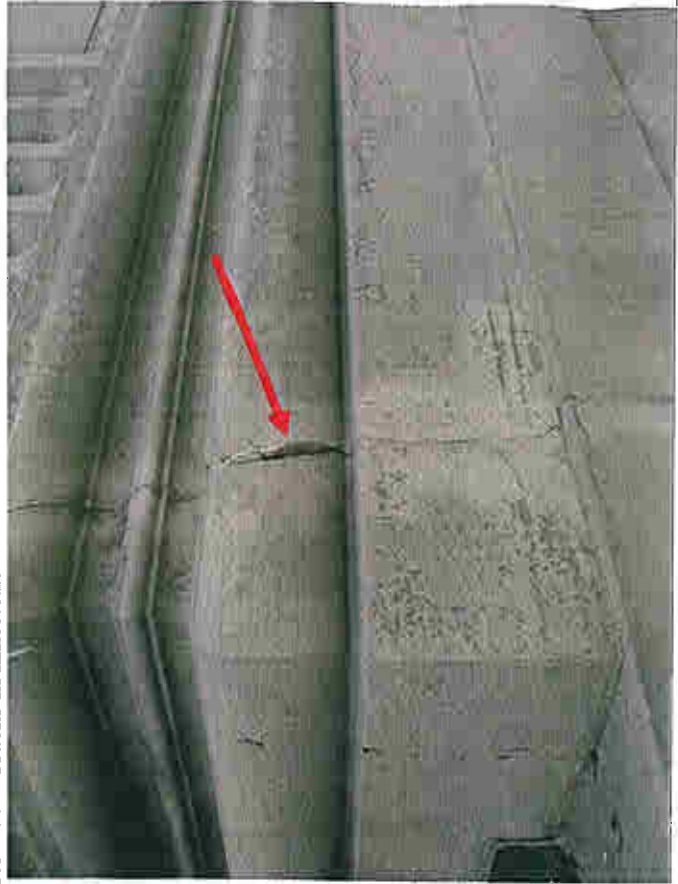
Photo #44 – Cracks in limestone
